PIC16(L)F72X Family Silicon Errata and Data Sheet Clarification

The PIC16(L)F72X family devices that you have received conform functionally to the current Device Data Sheet (DS41341E), except for the anomalies described in this document.

The silicon issues discussed in the following pages are for silicon revisions with the Device and Revision IDs listed in [Table 1](#). The silicon issues are summarized in [Table 2](#).

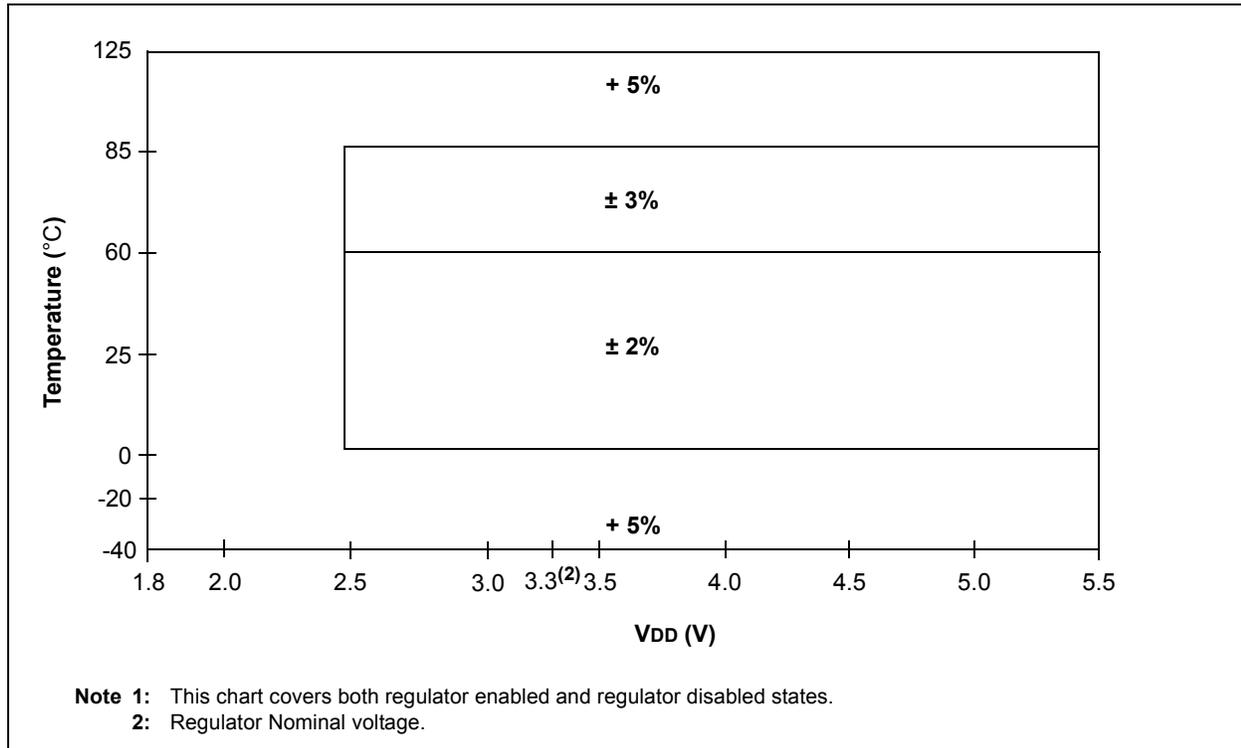
FIGURE 1: HFINTOSC FREQUENCY ACCURACY OVER DEVICE V_{DD} AND TEMPERATURE⁽¹⁾

The frequency tolerance of the internal oscillator is $\pm 2\%$ from 0-60°C and $\pm 3\%$ from 60-85°C (see [Figure 1](#)).

None.
