Silicon identification

This document applies to the part numbers of STM32F091xB/xC devices listed in [Table 1](#) and their silicon revisions shown in [Table 2](#).

[Section 1](#) gives a summary and [Section 2](#) a description of device limitations, with respect to the device datasheet and reference manual RM0091.

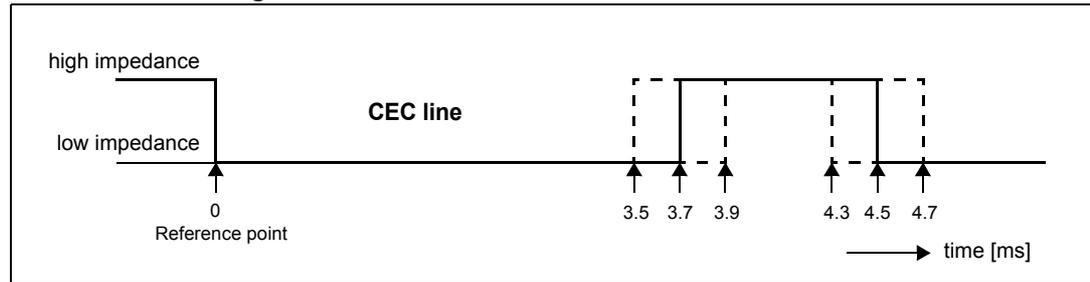
Figure 1. HDMI-CEC start bit format with tolerances

2.8 CEC**2.8.1 Transmission blocked when transmitted start bit is corrupted****Description**

When the HDMI-CEC communication start bit transmitted by the device is corrupted by another device on the CEC line, the CEC transmission is stalled.

The start bit timing standard tolerances are shown in [Figure 1](#). The start bit is initiated by the device by driving the CEC line low (reference point). After 3.7 ms, the device releases the

CEC line and starts checking its level. The following conditions must be met for the start bit to be valid:

- the CEC line goes high no later than 3.9 ms (4.05 ms with extended tolerance) from the reference point
- a falling edge on the CEC line does not occur earlier than 4.3 ms (4.15 ms with extended tolerance) from the reference point

If one of these conditions is not met, the transmission is aborted and never automatically retried. No error flag is set and the TXSOM (Tx Start Of Message) bit is not cleared.

A way to work this limitation around is for the system-level CEC application software to start a time-out counter when setting TXSOM bit and stop it upon TXBR or TXEND event. In case of time-out, the HDMI-CEC functional block is disabled then enabled, by setting the CECEN bit in CEC_CR register to 0 then to 1. This clears the TXSOM bit.
