Silicon identification

This errata sheet applies to the revision A, Z, Y and X of STMicroelectronics STM32L051x6/8 microcontrollers.

The STM32L051x6/8 devices feature an ARM® 32-bit Cortex®-M0+ core.

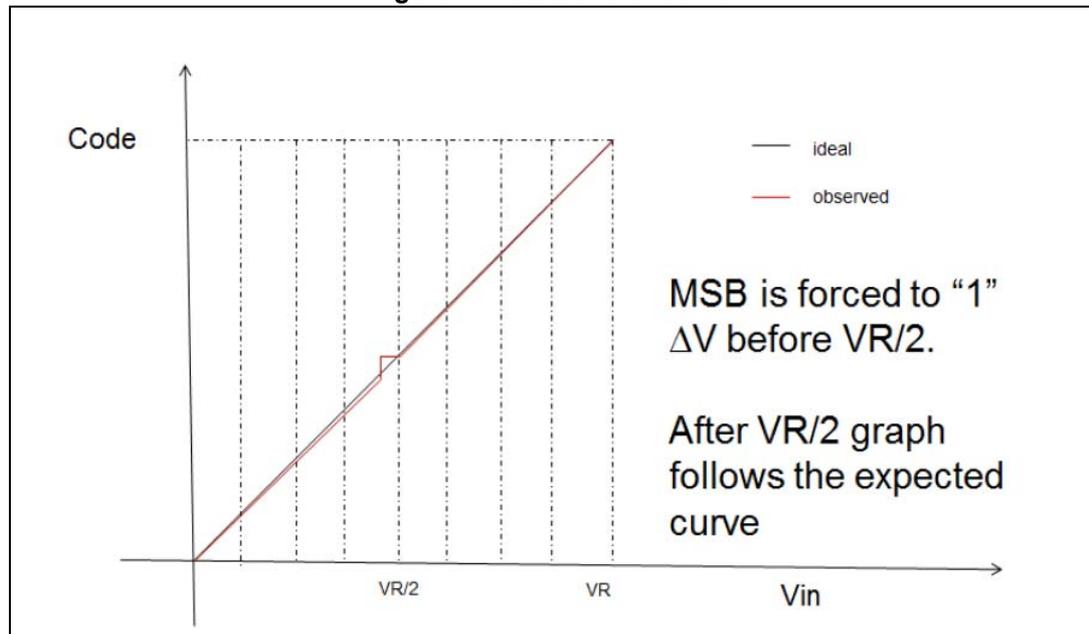
Figure 1. Data transfer curve

When V_{REF+} is lower than V_{DDA} , and only in this case, the data MSB is forced to '1' just before V_{IN} reaches $V_{REF+}/2$. As a result, the data transfer curve shows a discrepancy around $V_{REF+}/2$ (see [Figure 1](#)).

Note: The transfer curve behaves as expected when V_{IN} is strictly lower or higher than $V_{REF+}/2$.
