## Silicon identification

This document applies to the part numbers of STM32F072x8/xB devices listed in [Table 1](#) and their silicon revisions shown in [Table 2](#).

[Section 1](#) gives a summary and [Section 2](#) a description of device limitations, with respect to the device datasheet and reference manual RM0091.

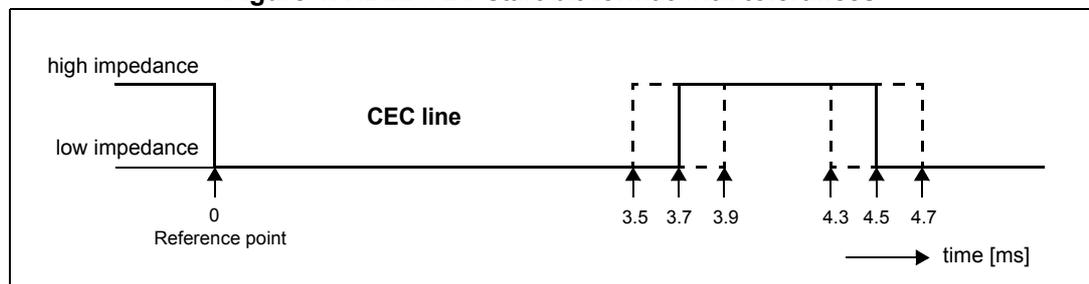
**Figure 1. HDMI-CEC start bit format with tolerances**

This failure is unlikely to happen as the CEC start bit corruption by another device can only occur if that device does not respect the CEC communication protocol.

The start bit timing standard tolerances are shown in *Figure 1*. The start bit is initiated by the device by driving the CEC line low (reference point). After 3.7 ms, the device releases the CEC line and starts checking its level. The following conditions must be met for the start bit to be valid:

If one of these conditions is not met, the transmission is aborted and never automatically retried. No error flag is set and the TXSOM (Tx Start Of Message) bit is not cleared.

A way to work this limitation around is for the system-level CEC application software to start a time-out counter when setting TXSOM bit and stop it upon TXBR or TXEND event. In case of time-out, the HDMI-CEC functional block is disabled then enabled, by setting the CECEN bit in CEC\_CR register to 0 then to 1. This clears the TXSOM bit.
