STM32F048C6/G6/T6 device limitations

Silicon identification

This document applies to the STM32F048C6/G6/T6 devices and their silicon revisions shown in [Table 1](#).

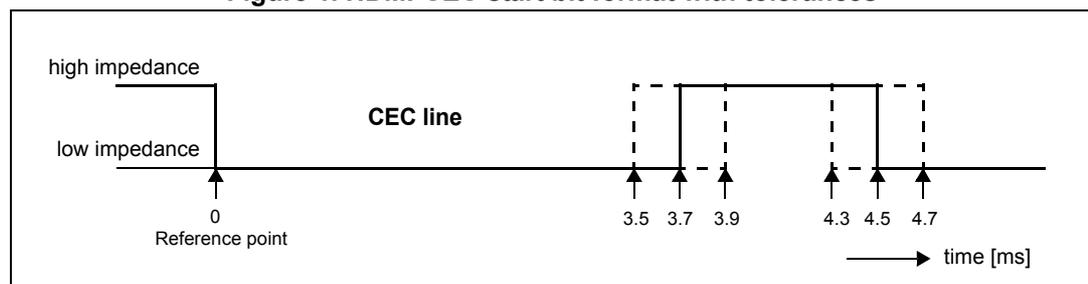
Figure 1. HDMI-CEC start bit format with tolerances

When the HDMI-CEC communication start bit transmitted by the device is corrupted by another device on the CEC line, the CEC transmission is stalled.

The start bit timing standard tolerances are shown in [Figure 1](#). The start bit is initiated by the device by driving the CEC line low (reference point). After 3.7 ms, the device releases the CEC line and starts checking its level. The following conditions must be met for the start bit to be valid:

- the CEC line goes high no later than 3.9 ms (4.05 ms with extended tolerance) from the reference point
- a falling edge on the CEC line does not occur earlier than 4.3 ms (4.15 ms with extended tolerance) from the reference point

If one of these conditions is not met, the transmission is aborted and never automatically retried. No error flag is set and the TXSOM (Tx Start Of Message) bit is not cleared.

A way to work this limitation around is for the system-level CEC application software to start a time-out counter when setting TXSOM bit and stop it upon TXBR or TXEND event. In case of time-out, the HDMI-CEC functional block is disabled then enabled, by setting the CECEN bit in CEC_CR register to 0 then to 1. This clears the TXSOM bit.
